# Parish of Weston under Penyard Public Rights of Way Survey Report No. 5

**Year Ending 31<sup>st</sup> March 2023**  
**John Smart**  
**Parish Footpaths Officer**

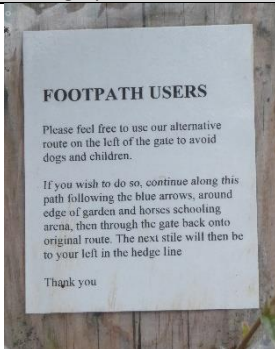
| WP25 | SE to NW | C.rd. at Weston Halt | | C.rd. 470 yds. E.N.E. of Lower Weston Fm | |
|---|---|---|---|---|---|
| WP25/1 | Fingerpost.<br>Helpful notice on gate of Stonewold.<br><br>Access from W side of Whitehall Road between St Marys Cottage and Stonewold. | Good.<br>Note: From this point a permissive footpath has been created by the landowner. | The “Footpath Users” notice and entrance to the narrow path should be made more prominent. | SO<br>63232<br>23533 | |
